2016 VOLVO D13

Guardol FE® Engine Teardown Results

This 2016 Volvo D13 powered a rig in coast-to-coast operation using a tandem driving team from a Youngstown, Ohio area fleet. Oil drains were at 30,000 miles using Guardol FE[®] 10W-30 (FA-4), accumulating 762,000 miles at the time of tear down. Performance is notable in that Volvo does not endorse the use of FA-4 oils.

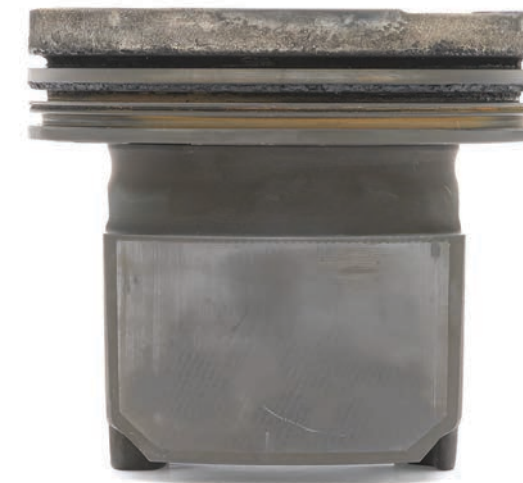
Piston 1 - Thrust

Engines accumulating this kind of mileage in heavy haul service would typically exhibit varying amounts of medium and heavy carbon deposits in the ring grooves. In this case there is only light carbon and virtually no piston skirt scuffing. Guardol FE 10W-30 protects where it counts.

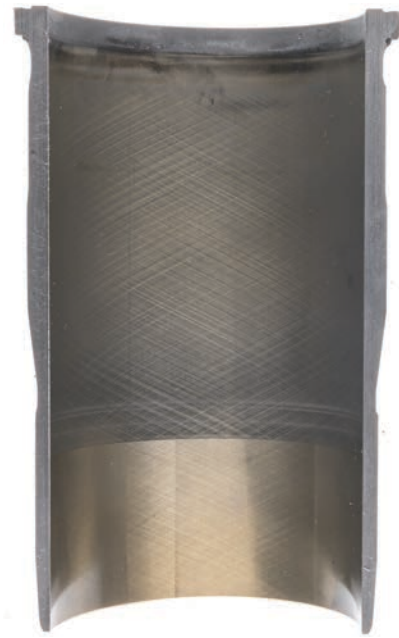
Liner 1A

Cylinder liners are subject to extensive heat and friction over the life of an engine. These representative examples show they are free from scuffing (cross-hatching looks great) and there's very minimal wear in the ring turn-around zone.

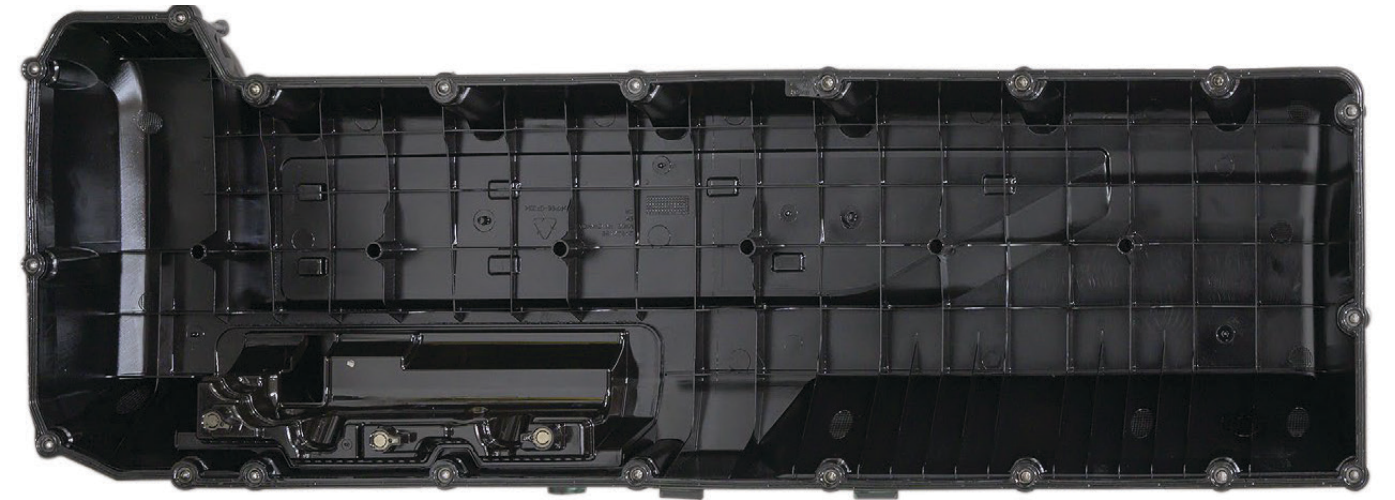
Rocker Cover

The oil pan and rocker cover are where sludge is often found in engine teardowns. Close inspection of the photos here tell a different story.

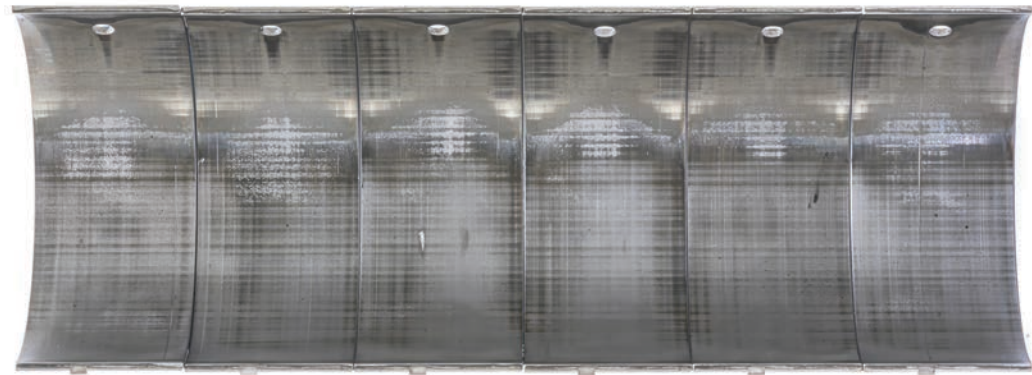
Rod Bearing Upper

Rod bearings show little to no wear. Guardol FE® 10W-30 provides maximum durability.

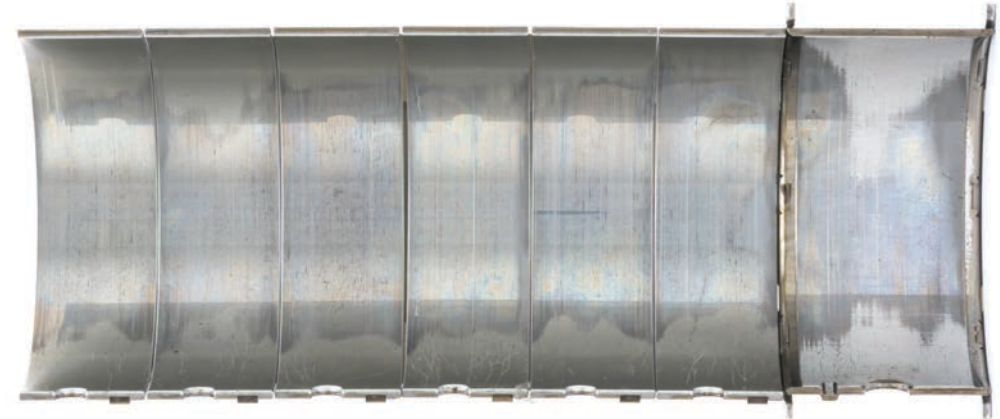
Cam Bearing Upper

Because the Volvo cam shaft is larger than most other manufacturers, performance here is critical. Effective film strength of our FA-4 10W-30 provides all the protection you need to assure long life of the engine.
