2014 DETROIT DIESEL DD13

Guardol FE® Engine Teardown Results

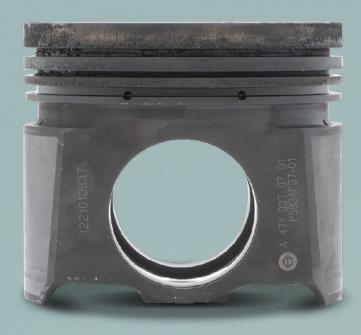
These parts were pulled from a 2014 Detroit Diesel DD13. They belong to an Atlanta, Georgia-based fleet operating refrigerated units in coast-to-coast service. All oil drains were performed at 45,000 mile intervals using Guardol FE® 10W-30 (FA-4). At the time of this teardown, the odometer was pushing nearly 900,000 miles.

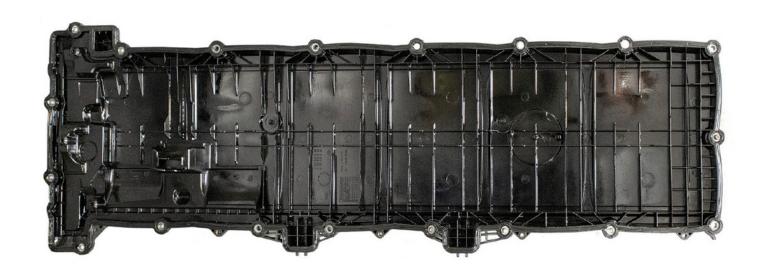
Rocker Cover

The oil pan and rocker cover is where sludge forms inside high-mileage engines. Close inspection of these photos of parts protected by Guardol FE® tell a different story.

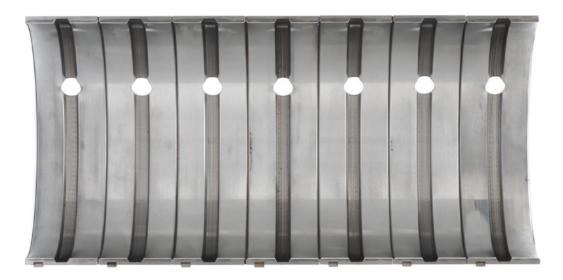
Main Bearing Upper

Bearings are where a poor performing product would quickly be exposed. The excellent High Temperature/High Shear (HTHS) properties of our FA-4 oil provide protection equivalent to our premium CK-4 15W-40.

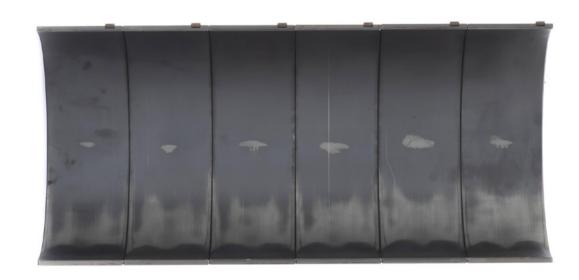
Rod Bearing Upper

Rod bearings show little to no wear. Guardol FE® 10W-30 provides maximum durability.
