2016 VOLVO D13

Guardol FE® Engine Teardown Results

This 2016 Volvo D13 powered a rig in coast-to-coast operation using a tandem driving team from a Youngstown, Ohio area fleet. Oil drains were at 30,000 miles using Guardol FE[®] 10W-30 (FA-4), accumulating 762,000 miles at the time of tear down. Performance is notable in that Volvo does not endorse the use of FA-4 oils.

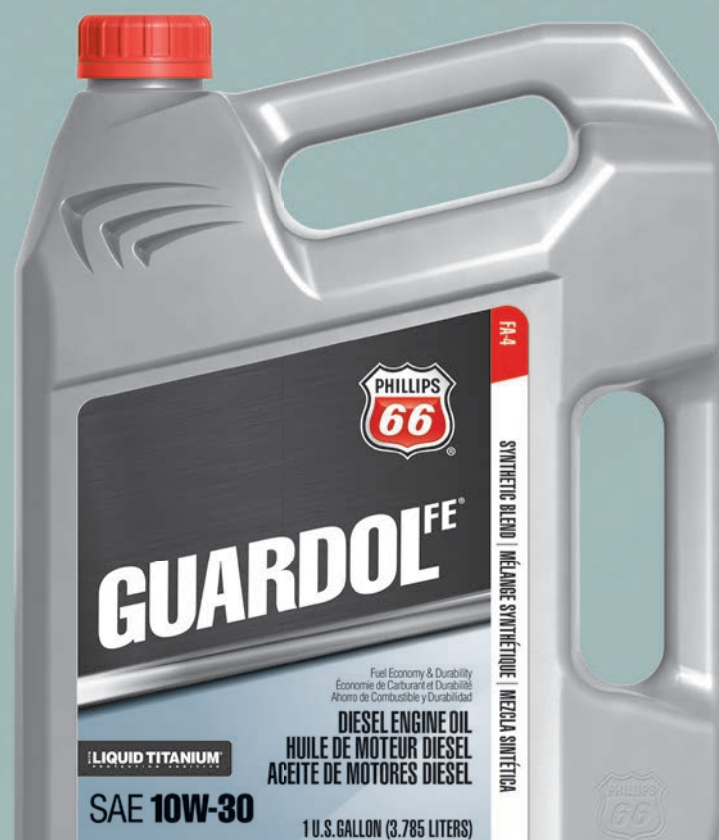
Engines accumulating this kind of mileage in heavy haul service would typically exhibit varying amounts of medium and heavy carbon deposits in the ring grooves. In this case there is only light carbon and virtually no piston skirt scuffing. Guardol FE 10W-30 protects where it counts.
